## How PT&P Repaired Another OEM's 20,000 lb Constant Spring Hangers in 2 Days During an Active Turbine Outage

When an active turbine outage required immediate action, PT&P repaired and refurbished two constant spring hangers designed to support a 20,000-pound load each, originally manufactured by another OEM.

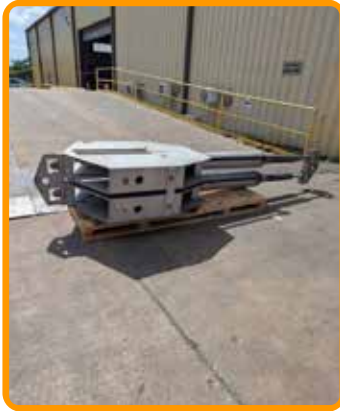
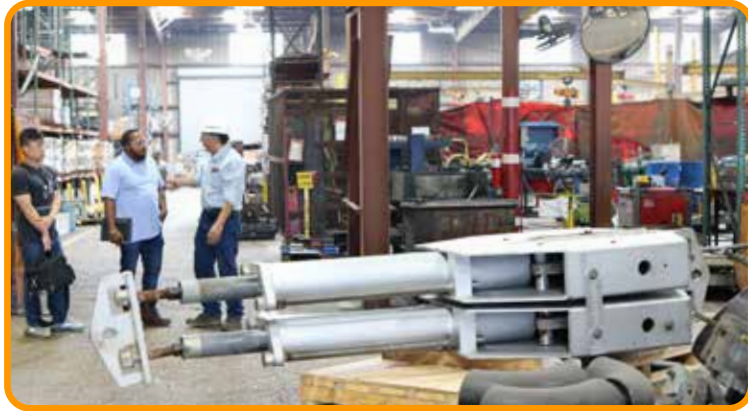
Emergency repair of two constant spring hangers at PT&P restored and ready for return to service

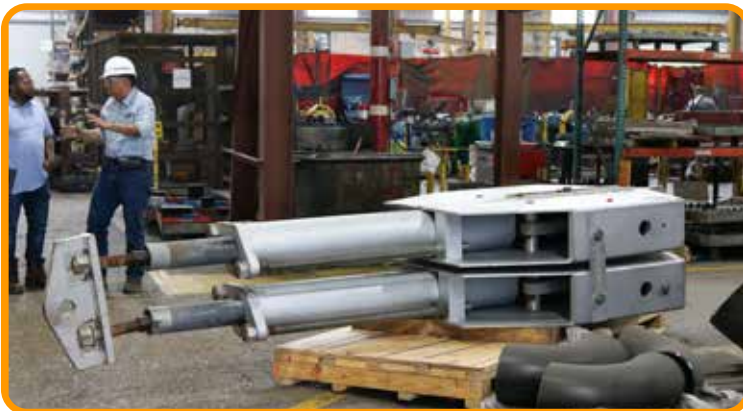
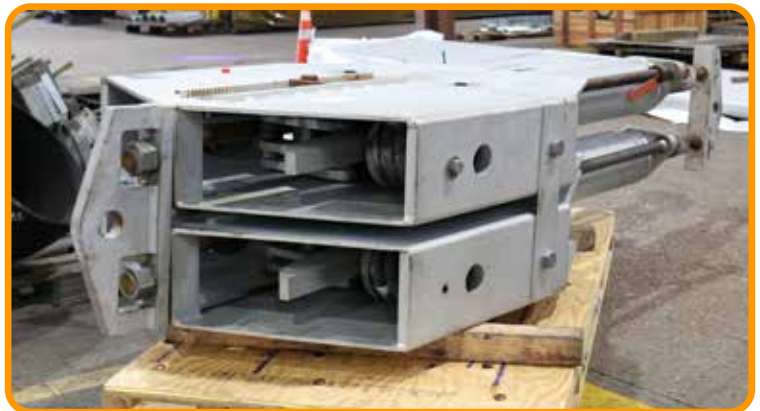
Both units disassembled and inspected at PT&P's Houston facility

| Stage | Activity | Timing |
|---|---|---|
| Disassembly & Inspection | Full teardown; component-level inspection of spring coils, cam, and load-bearing hardware; damage assessment documented | Day 1 |

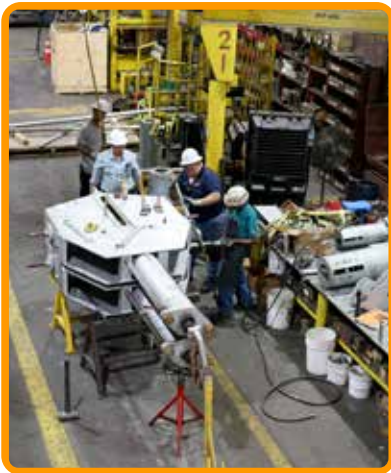
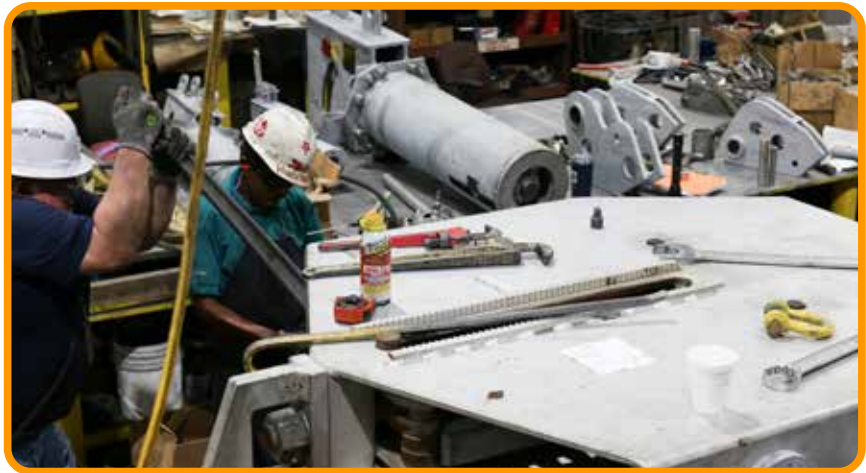
Damaged components repaired and both units rebuilt to original specifications

| Stage | Activity | Timing |
|---|---|---|
| Component Repair & Rebuild | Damaged components repaired or replaced; both units rebuilt to original load and travel specifications | Day 1-2 |

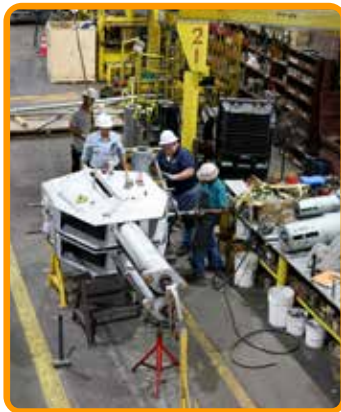
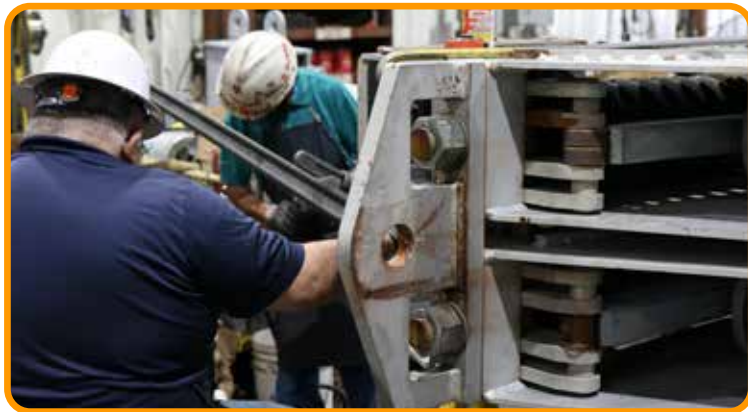
Final assembly and load testing completed before release

| Stage | Activity | Timing |
|---|---|---|
| QC & Load Verification | Final assembly and quality control were completed; load and travel verified against the 20,000 lb / 27" rating | Day 2 |

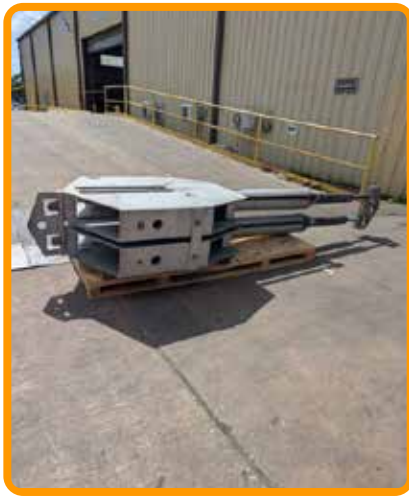
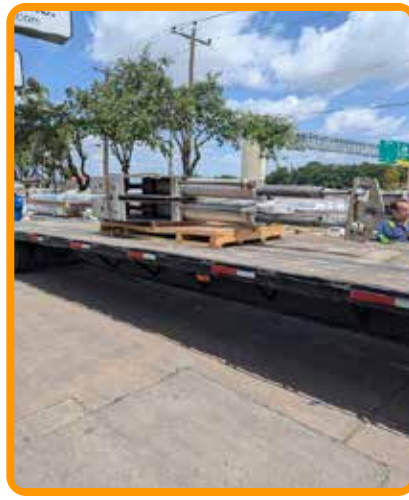
Both repaired units are packaged and ready for return shipment

| Stage | Activity | Timing |
|---|---|---|
| Shipment | Both units were certified, crated, and shipped back to the customer | Day 2 - Weekend turnaround completed, with both units shipped on Sunday. |
