# TECHNICAL BULLETIN

## Precision CAESAR Stress Audit Using Laser Scanning

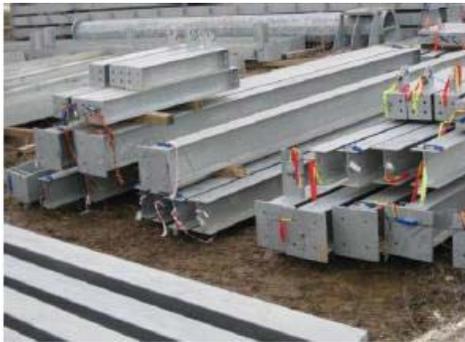
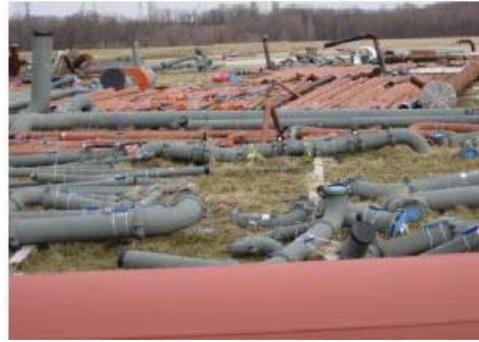
**Figure 1- Laydown Yard Photos**

One common issue we see across our 1,000+ audits of operating plants is that mid and long term maintenance issues are often sometimes created during initial plant construction. The issue is that construction is a very complex process with many, many opportunities for error. Anyone who has ever visited a laydown yard is certainly familiar with this issue.

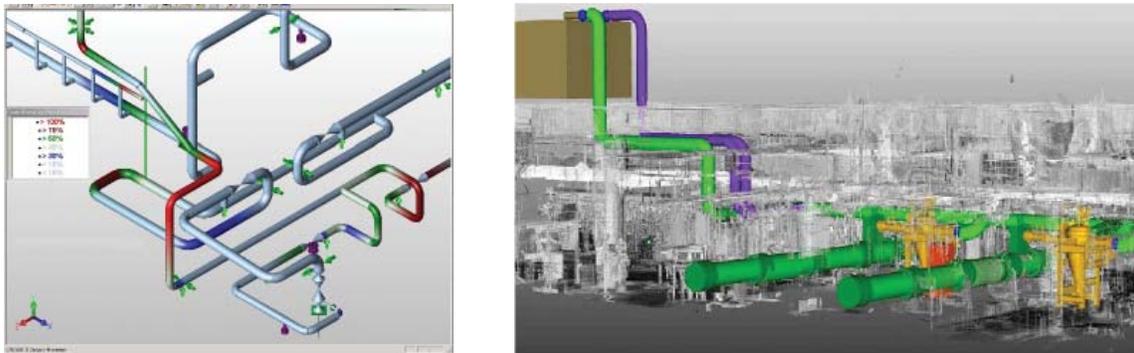
**Figure 2 - CAESAR Model and Piping Laser Scan**

PT&P offers a service which compares a laser scan of a line both in operation and in the installed mode with the CAESAR model leveraging a new software tool designed to greatly facilitate this analysis. The analysis provides a detailed comparison of the CAESAR model with the as-built drawing from the laser scan. This includes the following:

- Accurate placement of the supports – the as-built and CAESAR model is overlaid allowing for a precision check of support placements
- Accurate placement of the Piping in the Cold position
- Measuring deflection from a base point in the model versus the as-built

If there are variations from the as-built to the Caesar model, PT&P can diagnose the issues by:

- Checking placement of all elements when the line is not hot
- Recreating the as built by modifying the CAESAR model based PT&P experience (e.g. a spring with travel stop not pulled)
- Checking the temperature of the line versus design specification
